## Item No. 18 Town of Atherton

### **CITY COUNCIL STAFF REPORT – REGULAR AGENDA**

**SUBJECT: DISCUSSION OF NEXT STEPS FOR PARK IRRIGATION SYSTEMS AND  
UPDATE AND DIRECTION ON PARK STATUE RESTORATION**

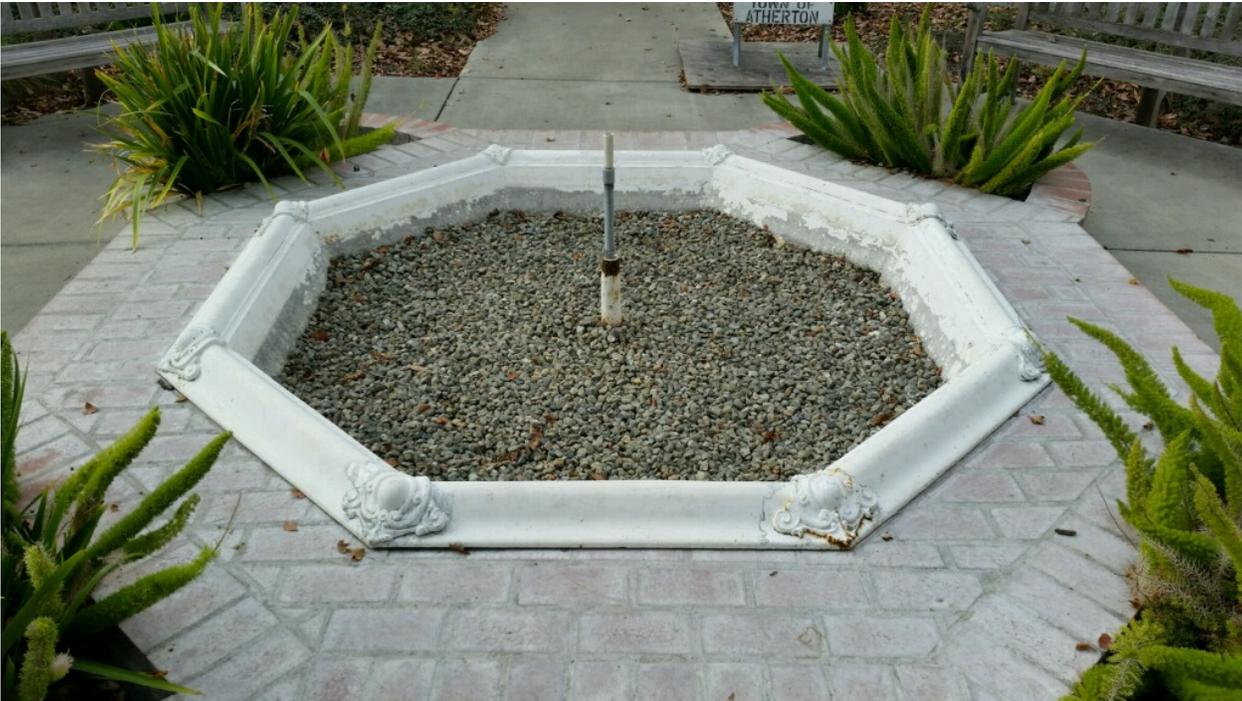
# PARK FOUNTAIN

In August 2015, the historic Park Fountain that is placed near the entrance of the park was toppled over by an unknown vandal. Investigation into the damage was not fruitful. The Fountain is made of a metal alloy and suffered some damage. The design of the fountain was such that it could be easily toppled and broken. Its weight is such that it is dangerous to anyone who might be in the path if it toppled. After the vandalism, the Fountain was not reset due to advanced issues with rust/breakage.

The cost for repairing these pieces is considerable. In the case of the Fountain, the Town has already spent a considerable amount of money on its resting site including a pump, filtration system and water filler. The biggest problem in keeping the Fountain running for staff was/is its immediate condition of rust. During the fountains restoration in 2009, an application of marine grade epoxy paint was added to the bead blasted finish of the fountain (bare metal). This finish began to immediately degrade and required removal and replacement.

Current condition of base/pedestal (above)

This work is all inclusive of mobilization, pack fountain or sculpture/unpack/remove basin, transport, strip paint, structural repairs, metalizing, paint, replication of missing pieces, prep and packing for shipping, reset fountain and plumbing or sculpture, report and maintenance plan.

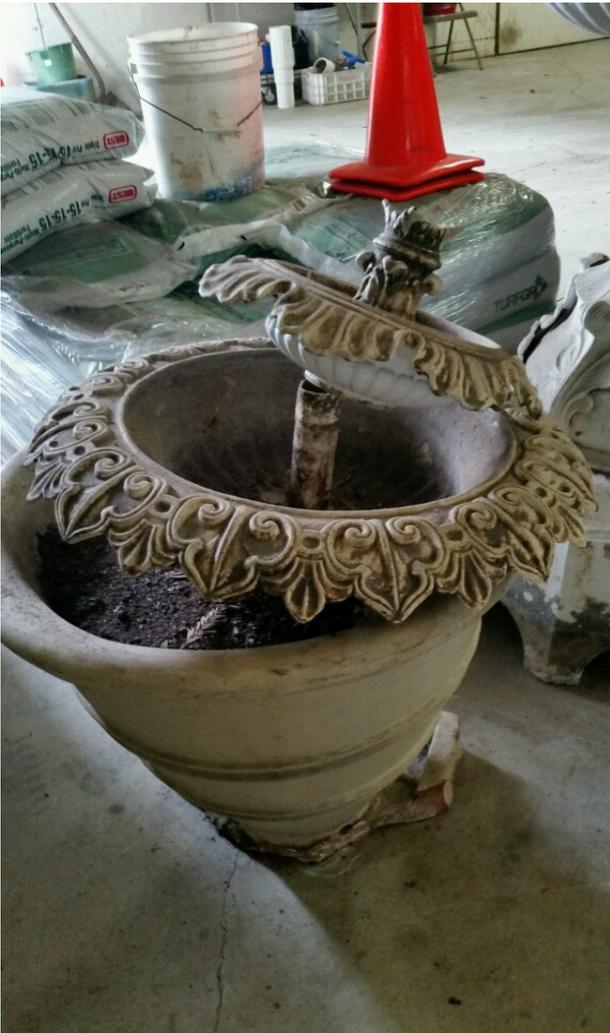
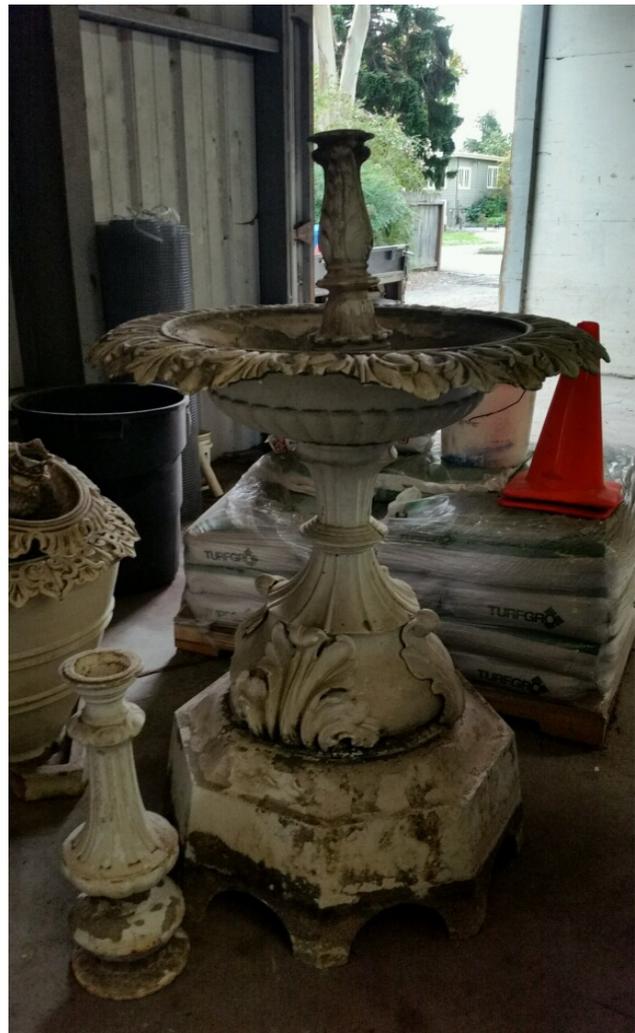
Parts stored in park corp. yard (below)

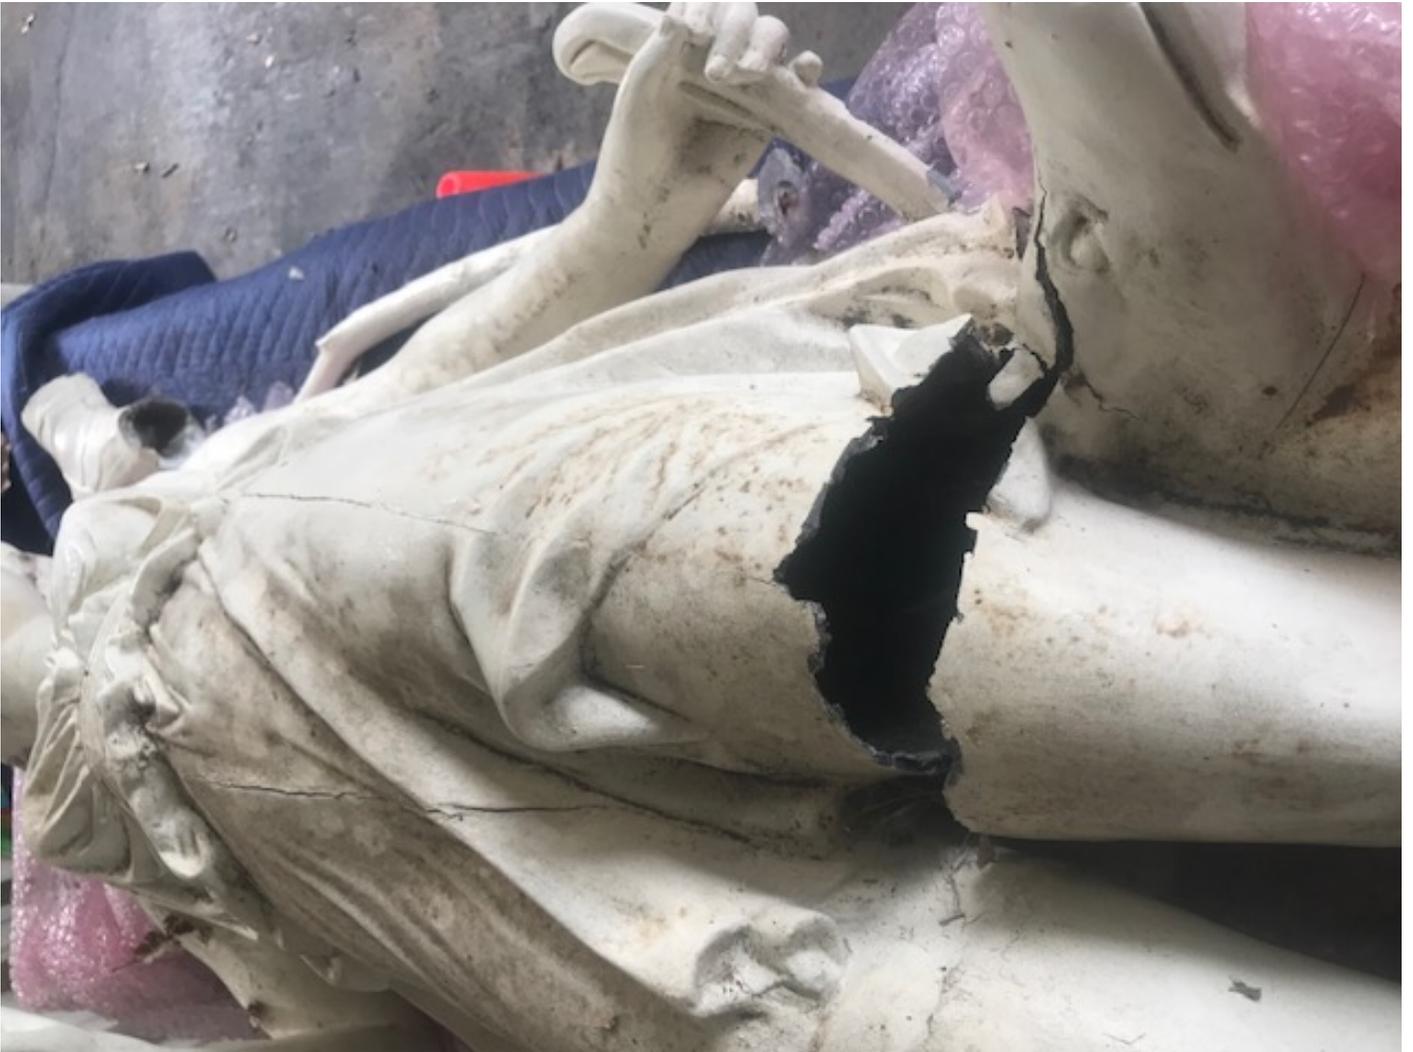
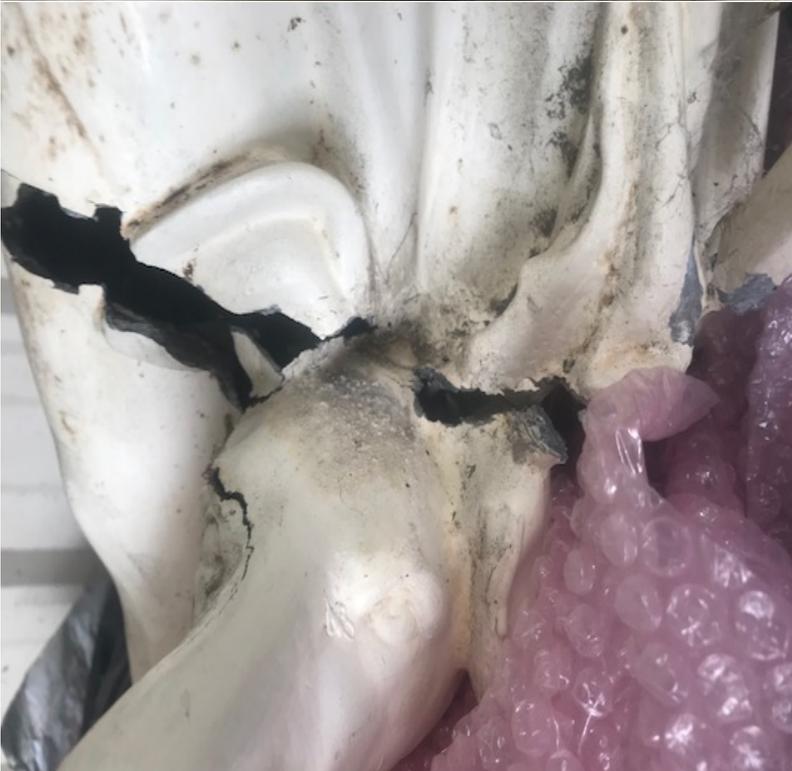
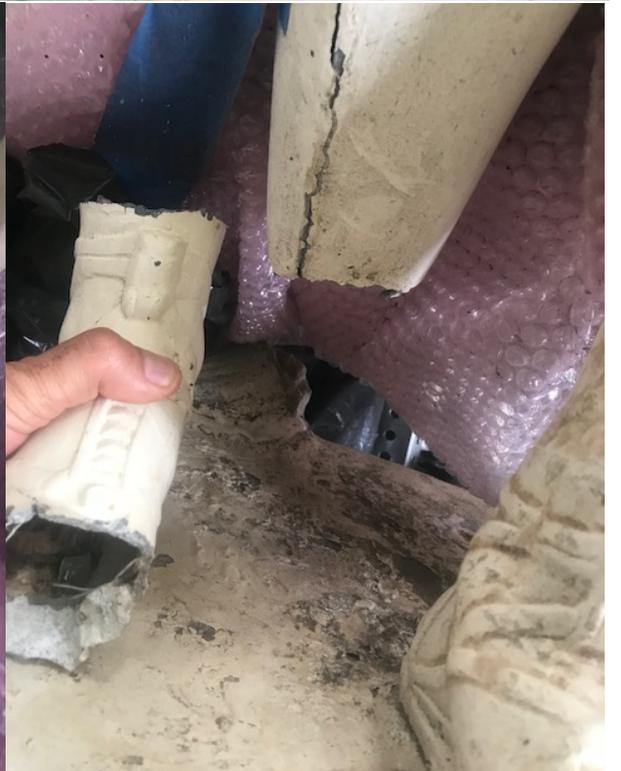
DIANA STATUE

In February 2016, following the installation of the new Event Garden at the park, staff attempted to install the Diana Statue in a place of prominence on her new pedestal. As staff carried the bubble-wrapped statue from the park vehicle to the new pedestal, the Statue literally crumbled apart from its own weight in their hands.

The Diana Statue has very serious structural problems. The alloy itself appears to be in a state of degradation. The damage done to the Statue by its own weight is repairable by only the most skilled of conservators.

It is possible that replicas of both of these pieces can be made of either concrete or fiberglass or a combination of both. Though the historic pieces would be lost to time, their application and story could remain intact. As it stands today, the Diana statue has already had some "alterations" that make it less than original and the same can be said for the Fountain.
