SUBJECT: HERITAGE TREE REMOVAL PERMIT FOR THE REMOVAL OF ONE HERITAGE TREE AT 228 ATHERTON AVENUE (APN 070-040-410)

Re: Hazard Tree Removal of Non Native Tree

Re: Tree Survey

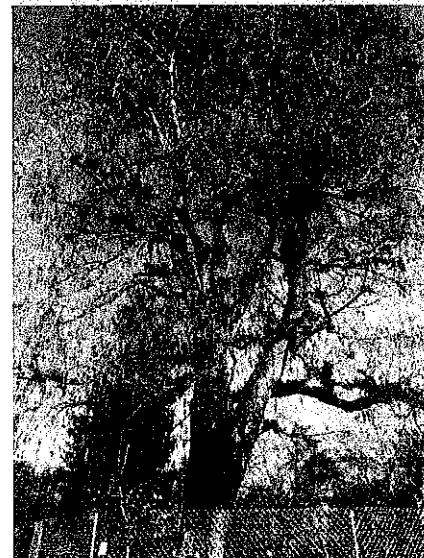
Trees with Co-dominant limbs are highly prone to limb failures. This tree has two locations with major co-dominant limbs. The first location is approximately 10' above grade where a very large limb splits off with a narrow angle of attachment (see image to right). When this limb fails it will fall on this property and cause damage to the new structures and/or its inhabitants.

Because of the hazard level represented by this tree I recommend its removal.

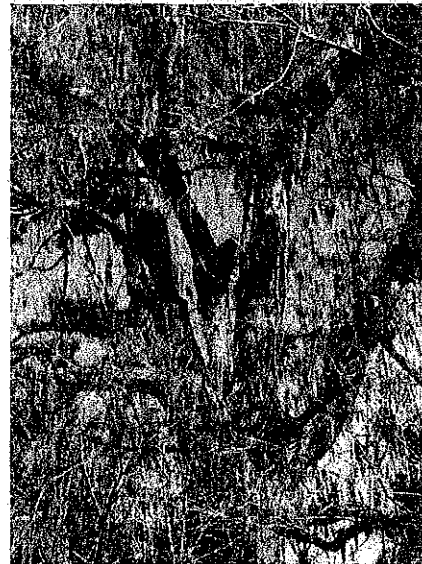
The second location for co-dominant stems is 2/3 the way up the tree (see image to right). At this location there are three main limbs coming out of the same location and a fourth limb coming out just below it. This area is highly prone to limb failures and when one of these limbs fails it will land on the new structure or its inhabitants. If the opposite limb fails it will land on the neighbor's driveway, their cars, or anyone in the driveway.

This tree currently has a co-dominant limb that has partially failed. The limb is still attached, but already cracked open and ready to fall (see image to right). This limb is indicative of how the other co-dominant limbs will fail in this tree.

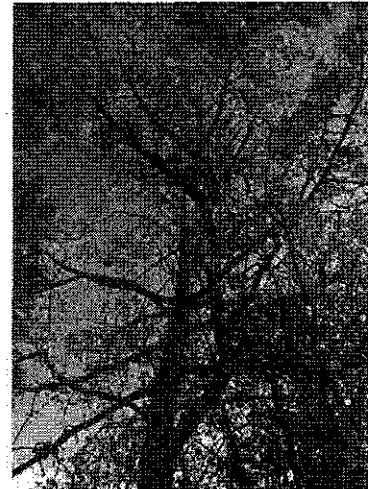
Tree #3 is a large Monterey Pine (see image to right) that is on the neighbor's property but close to the entry driveway of 228 Atherton Ave. This tree is dead and I recommend it be removed.

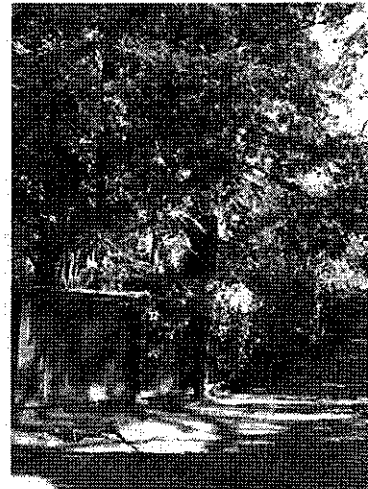
Trees #18 are three fairly large Redwoods on the neighbor's property (see image to right, below). These trees have roots in the existing driveway. The demolition of the existing driveway surface should be one of the final elements of the construction so it can be used as a construction access route that protects the roots.

The portions of the existing driveway that are located within the tree protection zone of these trees should be broken into pieces using a jackhammer and then collected in a skid steer bucket. The skid steer should remain on the existing driveway surface at all times. This should help reduce damage to the roots of these trees and reduce soil compaction. I recommend salvaging the existing base material for use below the new driveway surface. Adding additional base material to the existing layer of base is acceptable. A certified arborist should supervise the demolition of the driveway surface within the tree protection zone of these trees.

1. I recommend re-using the existing base to minimize the need for excavation into the root zone of these trees. If excavation is required it should not exceed 4-6 inches into the root zone of these trees. If further excavation is necessary than an air-spade should be used to expose these trees roots to determine the impact that this excavation work would have on these trees.

2. Any roots exposed during these construction activities that are larger than 2 inches in diameter should not be cut or damaged until the project arborist has an opportunity to assess the impact that removing these roots could have on the trees.

3. A certified arborist should supervise any excavation activities within the tree protection zone of these trees.
4. Biaxial Geo-grid can be used to successful minimize the thickness of the base material and compaction that is required for typical driveway construction.

5. Interlocking permeable pavers or permeable concrete should be used to allow water to reach the roots below the driveway surface.

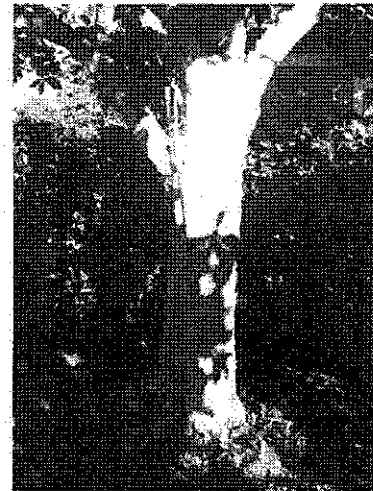
Tree #13 is a Magnolia tree (*Magnolia grandiflora* – see image to right) that is in Fair condition, but has an old post in its trunk. This tree is within the Building Envelope and will be removed.

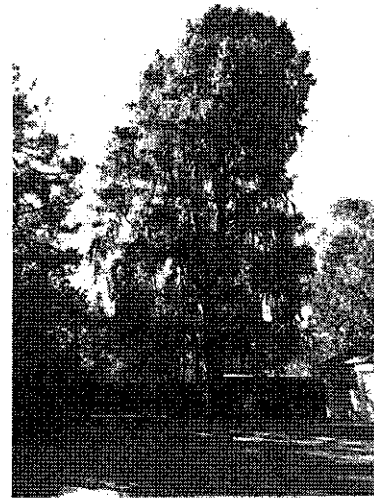
Tree #11 is a Bald Cypress (*Taxodium distichum* – see image to right). This is a somewhat usual tree for this area. This tree is difficult to work with from an aesthetic perspective. This tree is not common in Atherton landscapes and it is an aesthetic that is difficult to match. This tree should be pruned and shaped this winter.

The same driveway removal and surface replacement recommendations apply for this tree as with trees eighteen (see above). The home will be demolished and rebuilt in approximately the same location as the current garage. The demolition and excavation of this area must be supervised by a Certified Arborist. Currently the distance from the trunk to the proposed construction is within Industry Standards, but supervision will insure Tree Protection.
