DATE: PLANNING COMMISSION MEETING OF JULY 27, 2016

SUBJECT: REQUEST FOR THE REMOVAL OF THREE HERITAGE TREES AT 70 STERN LANE (APN 070-170-050)

ARBORIST REPORT

RE: **70 Stern Lane
Atherton, CA**

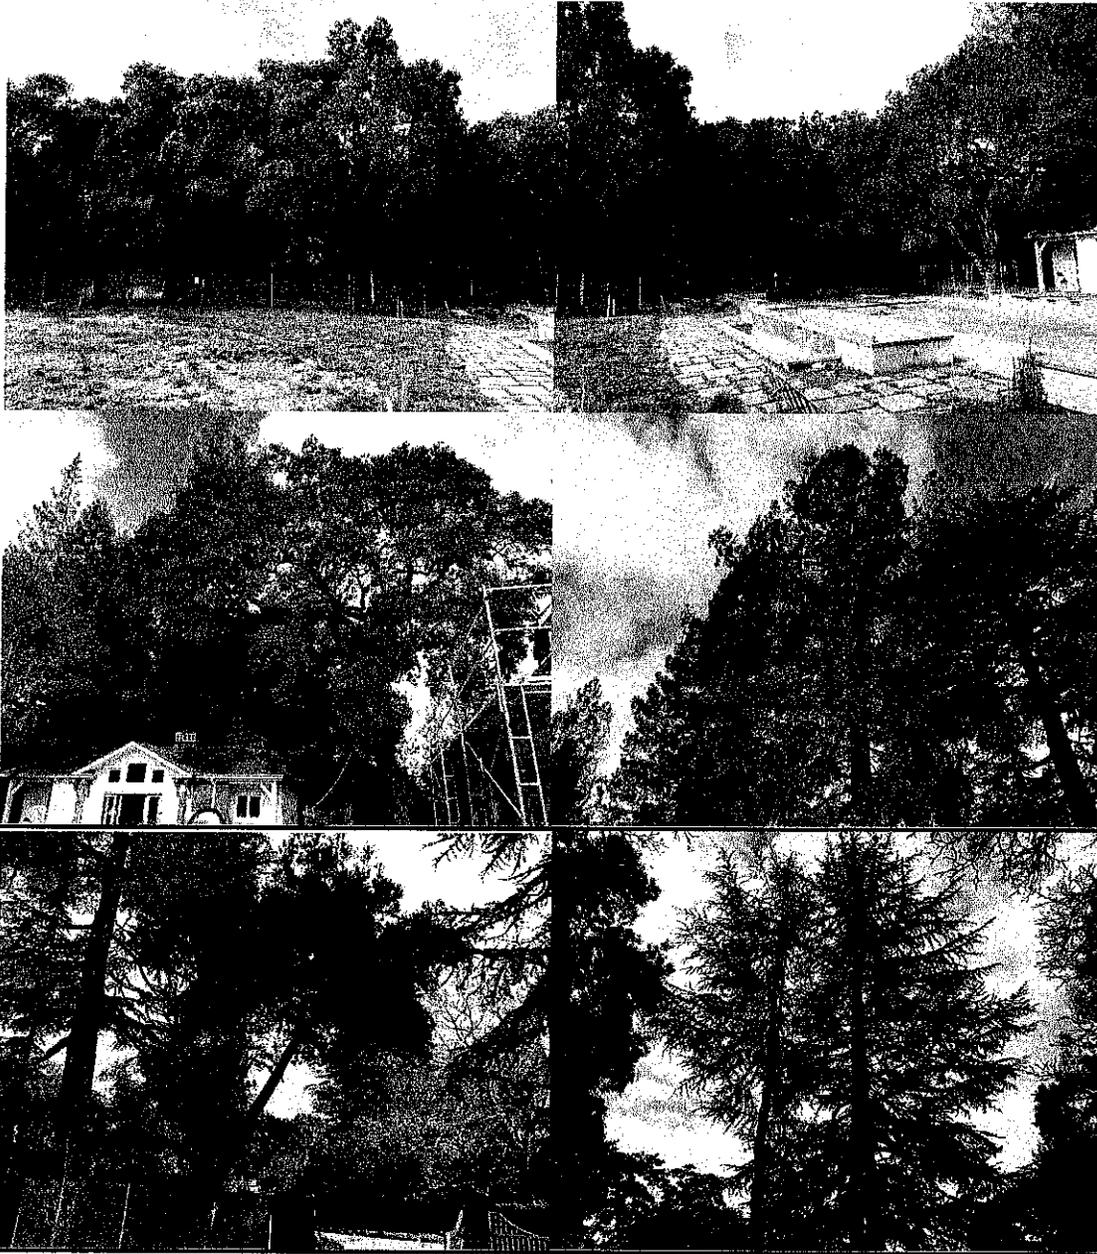
Tree numbers correspond to the site plan below. Tree Protection Zones have been established for each tree. Any grading or excavation within a designated TPZ must be accomplished by hand or digging. Deodar cedars 35-37 are surrounded by old mushrooms, the soil or the root flares should be sampled for root rots, these three trees are proposed for removal as part of site improvements.
